DELAWARE RIVER BASIN
SOUTH BRANCH NEWTON CREEK,
CAMDEN COUNTY
NEW JERSEY

HADDON LAKE DAM

NJ 00395

PHASE 1 INSPECTION REPORT
NATIONAL DAM SAFETY PROGRAM

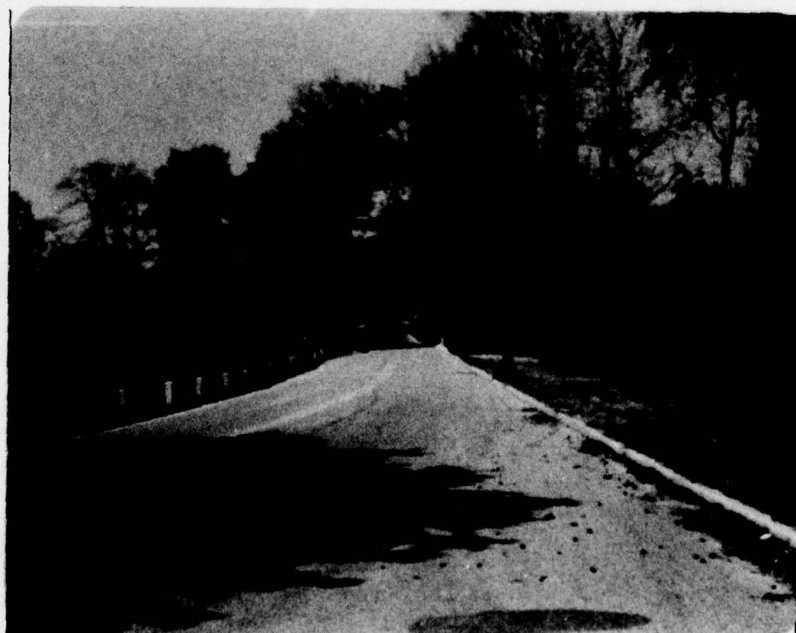
View of Crest Looking Southwest
